Contract #: 04-0120F4Cty: SF/ALA Rte: 80 PM: 13.2/13.9File #: 69.28**WELDING INSPECTION REPORT****Resident Engineer:**Pursell, Gary**Address:** 333 Burma Road**City:** Oakland, CA 94607**Report No:** WIR-004234**Date Inspected:** 06-Oct-2008**Project Name:** SAS Superstructure**OSM Arrival Time:** 1430**Prime Contractor:** American Bridge/Fluor Enterprises, a JV**OSM Departure Time:** 2230**Contractor:** Zhenhua Port Machinery Company, Ltd (ZPMC), Changxing Island **Location:** Shanghai, China**CWI Name:** NA**CWI Present:** Yes No**Inspected CWI report:** Yes No N/A**Rod Oven in Use:** Yes No N/A**Electrode to specification:** Yes No N/A**Weld Procedures Followed:** Yes No N/A**Qualified Welders:** Yes No N/A**Verified Joint Fit-up:** Yes No N/A**Approved Drawings:** Yes No N/A**Approved WPS:** Yes No N/A**Delayed / Cancelled:** Yes No N/A**Bridge No:** 34-0006**Component:** OBG Fabrication**Summary of Items Observed:**

Heavy shop #1

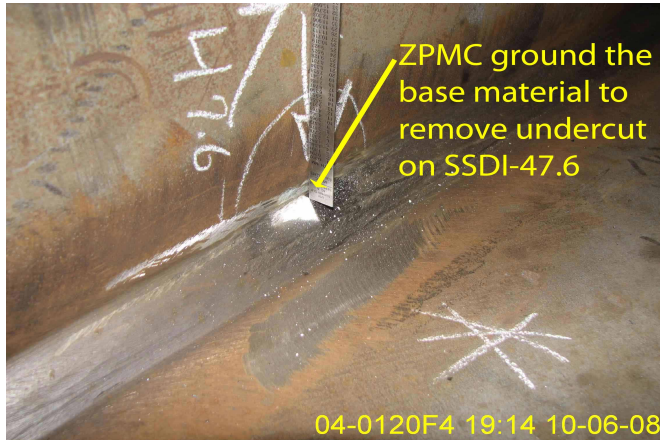
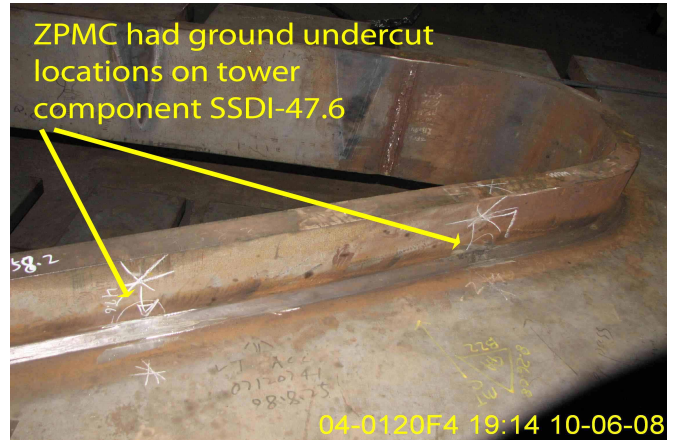
SSDI-38M: All accessible welds were visually inspected and the QA Inspector observed three welds had undercut that were greater than 1mm below flush. After the areas were weld repaired the welds appear to comply with project specifications. The QA Inspector performed random magnetic particle inspections of approximately 10 % length of half of the welds on SSDI-38M. The QA Inspector informed QA Inspector Mr. Mike Hasler that additional welds require magnetic particle inspections prior to QA green tag release.

SSDI- 47.6: All accessible welds were visually inspected and the QA Inspector observed two welds had portions where the undercut was greater than 1mm below flush. After the areas were weld repaired the welds appear to

comply with project specifications.
